BLACK LIQUOR RECOVERY BOILER ADVISORY COMMITTEE

MINUTES OF MEETING Crowne Plaza Hotel/Atlanta Airport Atlanta, Georgia April 4, 5 & 6, 2011

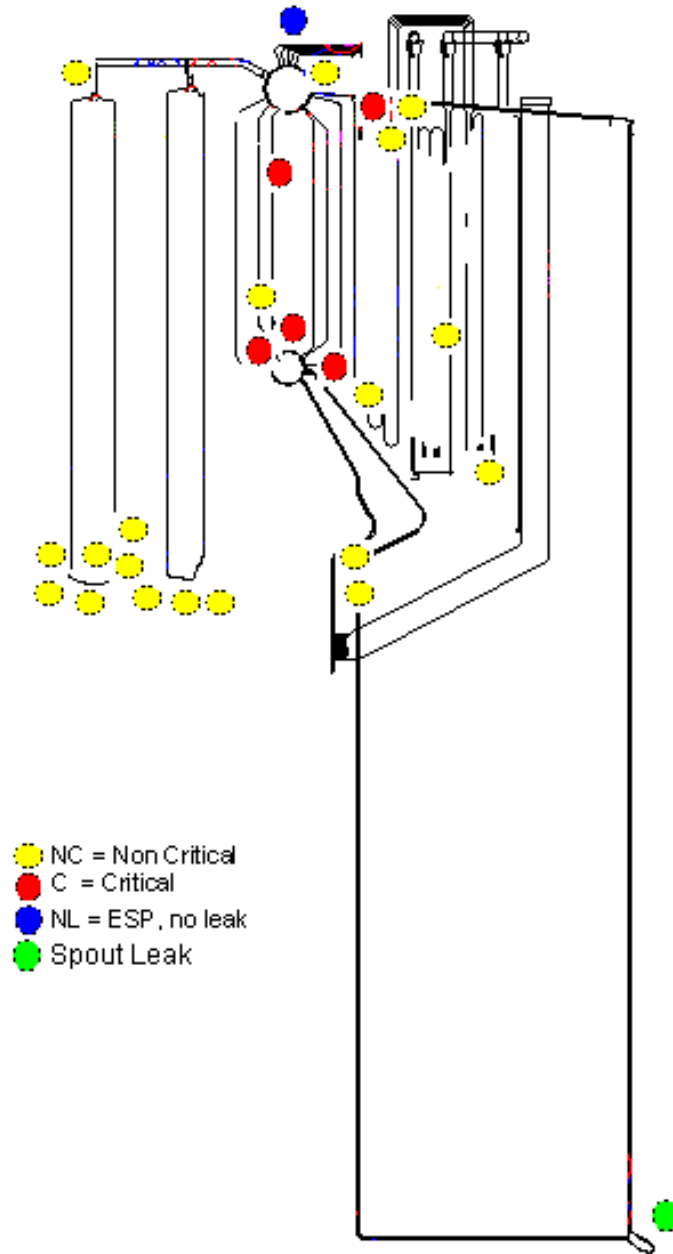
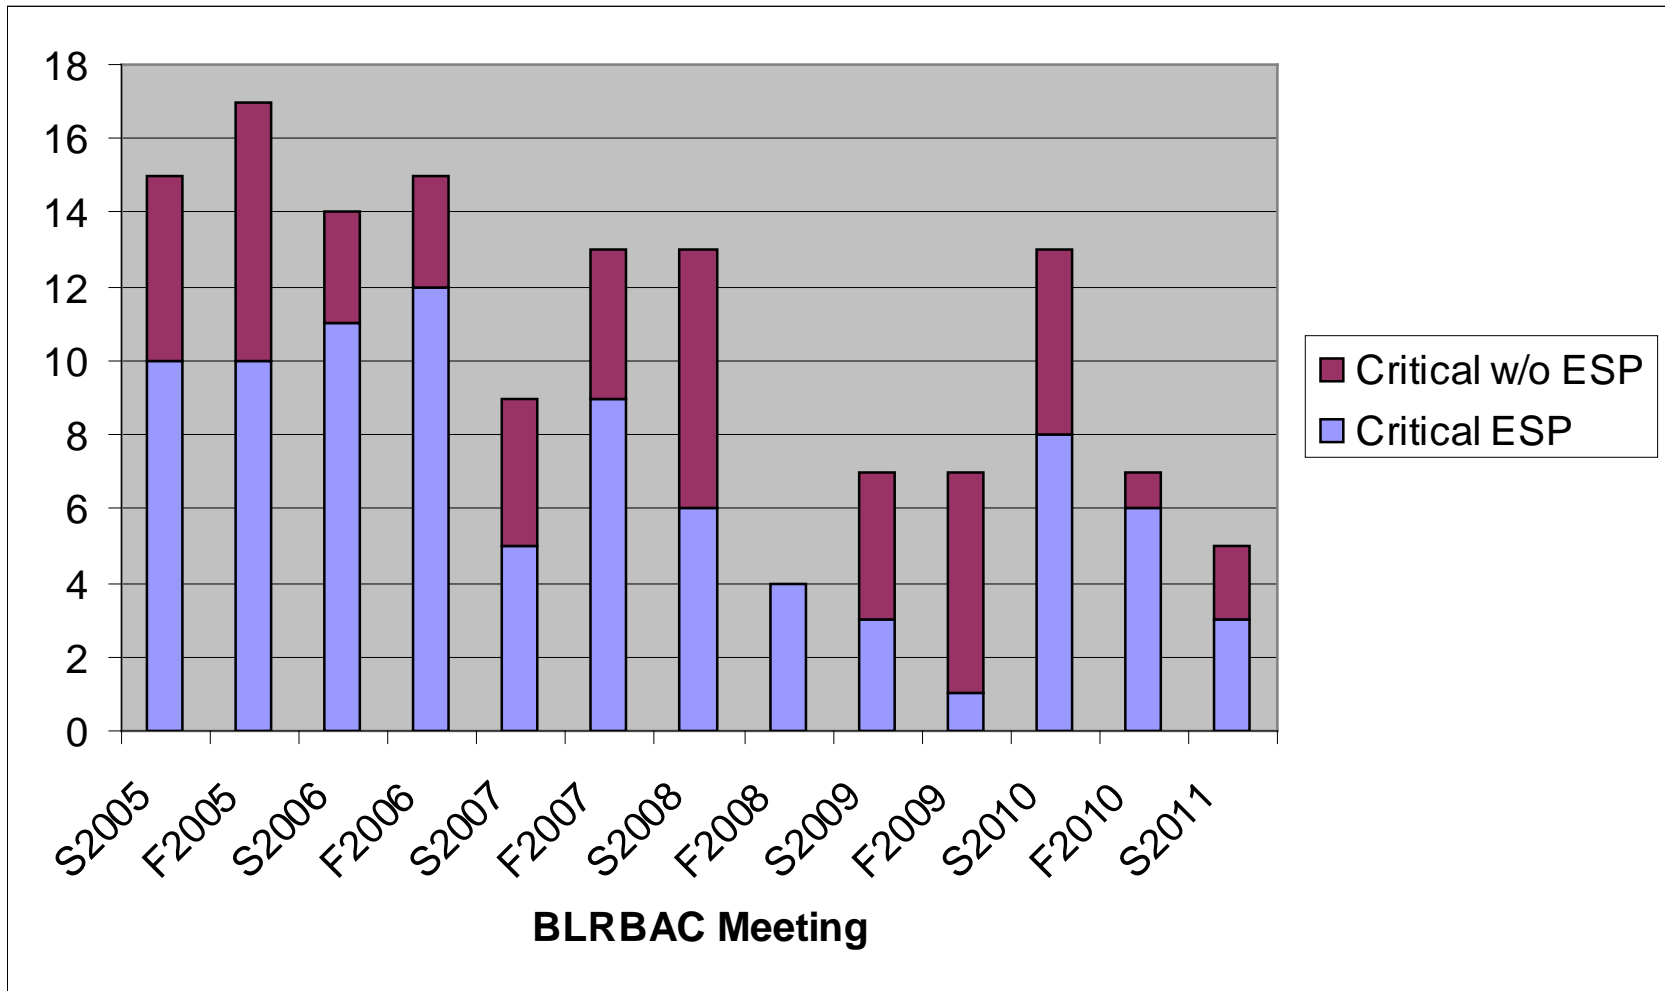
Figure 1

The general locations of the leaks for boilers in North America are shown in Figure 1, which displays a typical boiler, not representing any particular style or model. The yellow marks are the non-critical incidents and the red marks indicate the location of the critical incidents. There is one green mark for the spout failures and the one blue represents the ESP with no leak. One incident reported a non critical superheater leak but discovered a critical leak in the roof during the outage.

- 11 – Economizer
- 5 – Superheater
- 4 – Boiler Bank / Steam Drum
- 4 – Upper Furnace
- 1 – Screen
- 1 – ESP No Leak
- 1 – Smelt Spout Failure

Spring 2011 Leak Locations

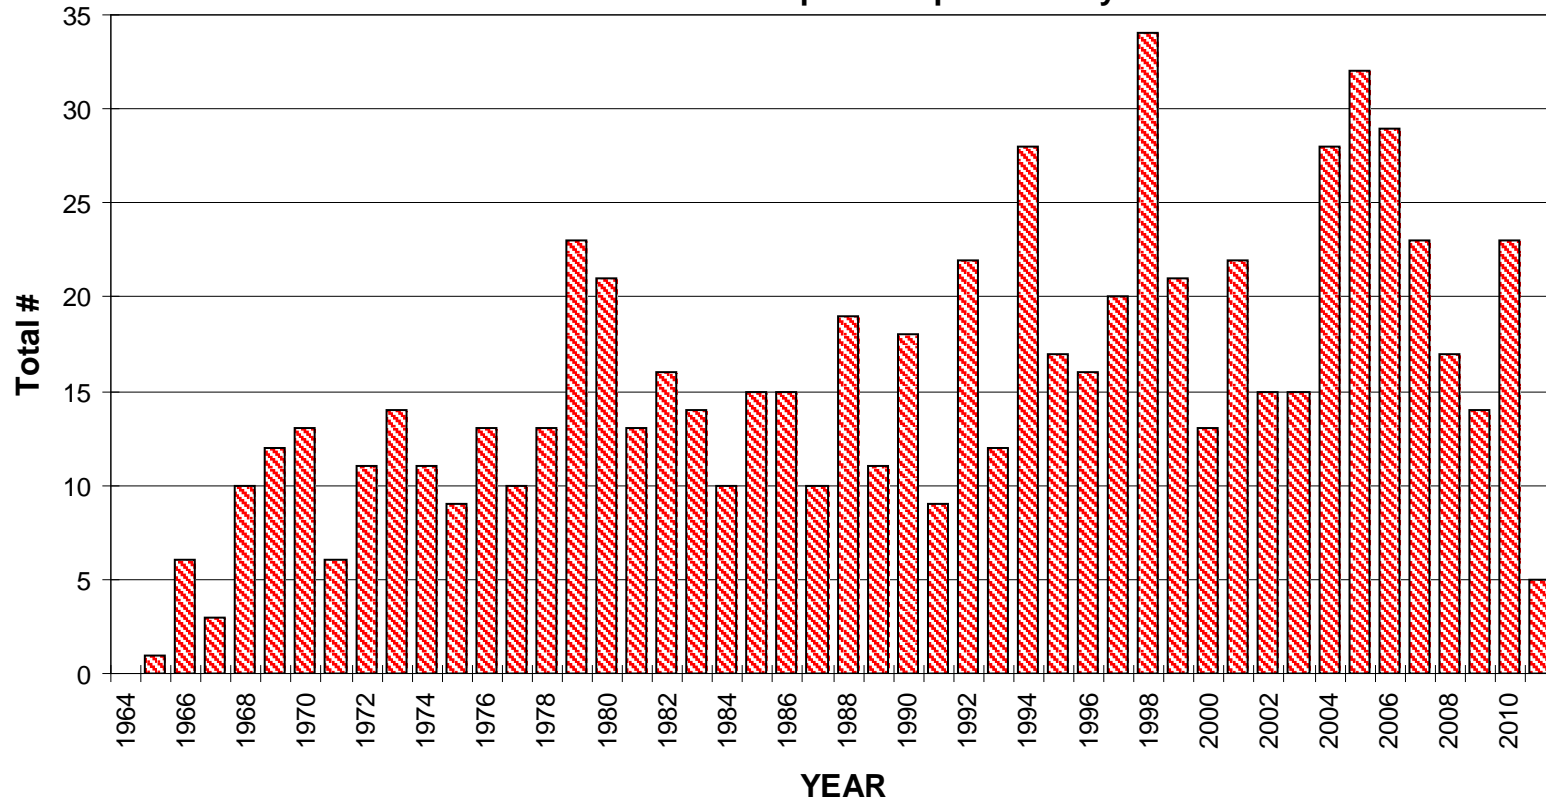
Figure 2

KRAFT RECOVERY BOILER CRITICAL INCIDENTS North America Pulp and Paper Industry

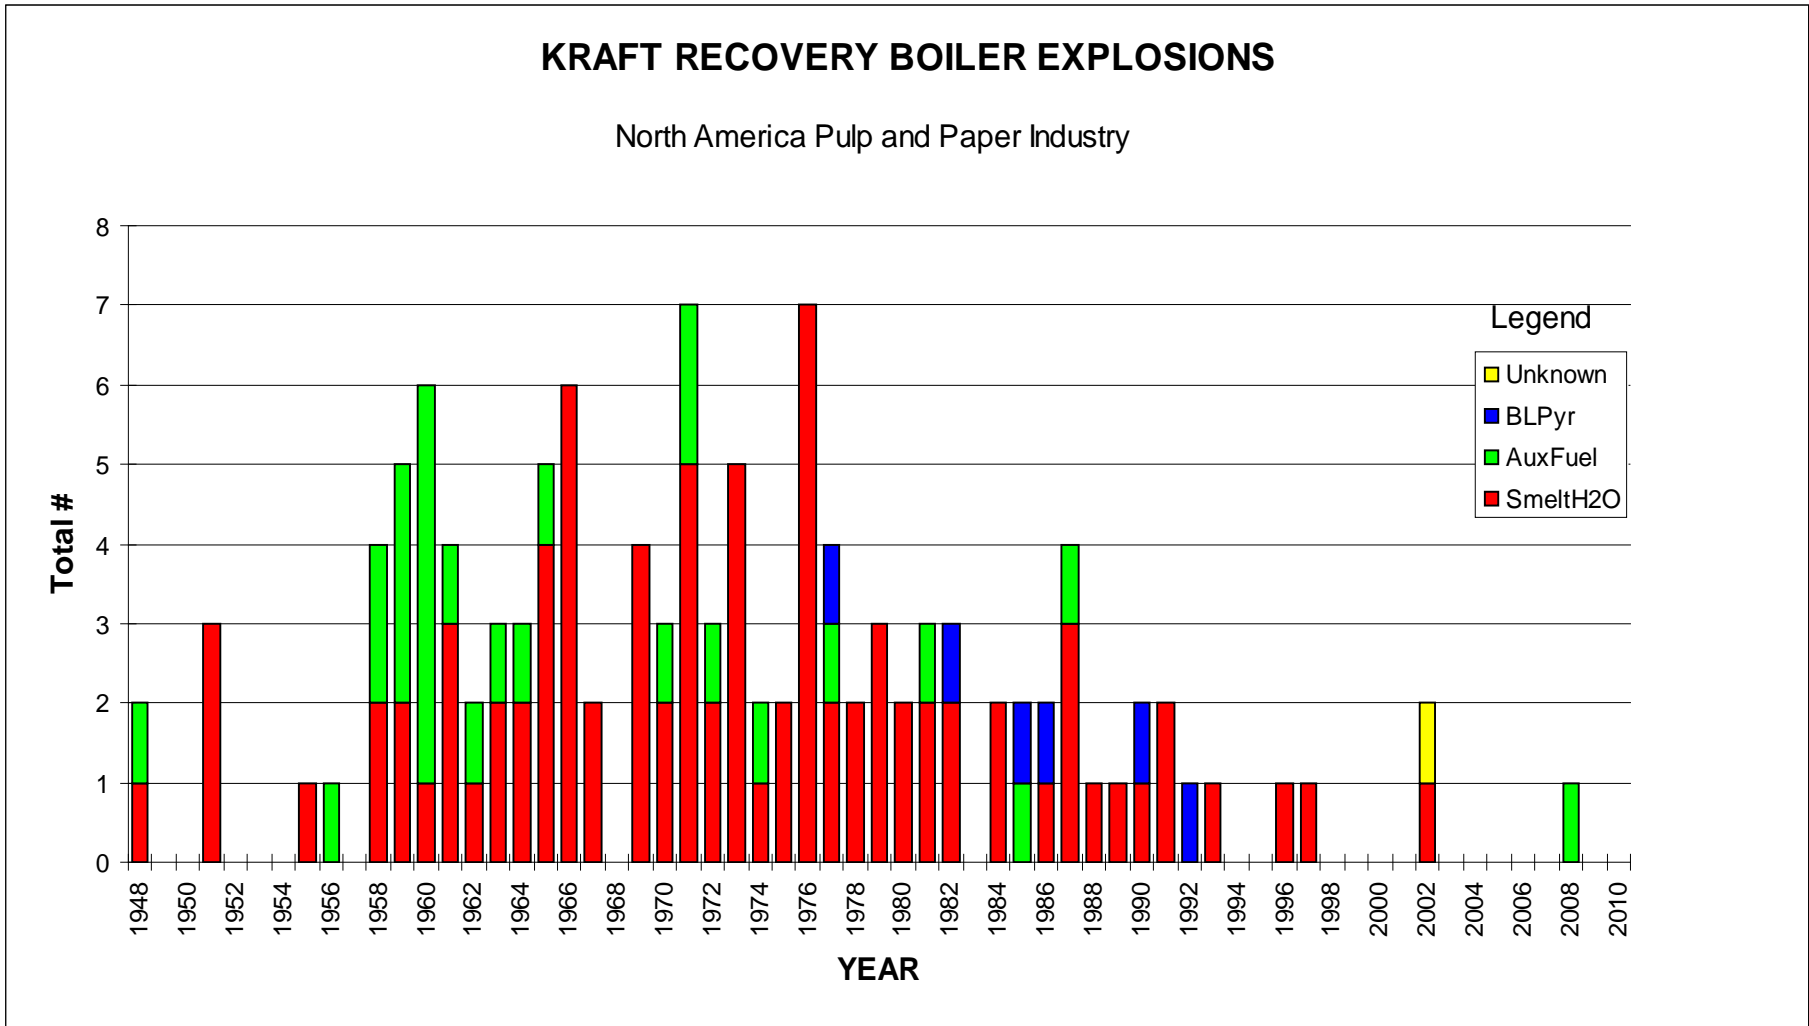
Figure 3 shows the critical incidents reported each year. The bar for 2011 represents the first half of the year so we are starting off the year below average. Figure 4 shows the history of Recovery Boiler Explosions showing the string of years without an explosion was broken with the Aux Fuel explosion at Vicksburg in 2008. The good news is that we have accumulated several years since then without an explosion.

(Critical Exposure Classification Began in 1965, Changed to Critical Incident in 1999)
