# BLACK LIQUOR RECOVERY BOILER

## ADVISORY COMMITTEE

### MINUTES OF MEETING

#### October 10, 11 & 12, 2011

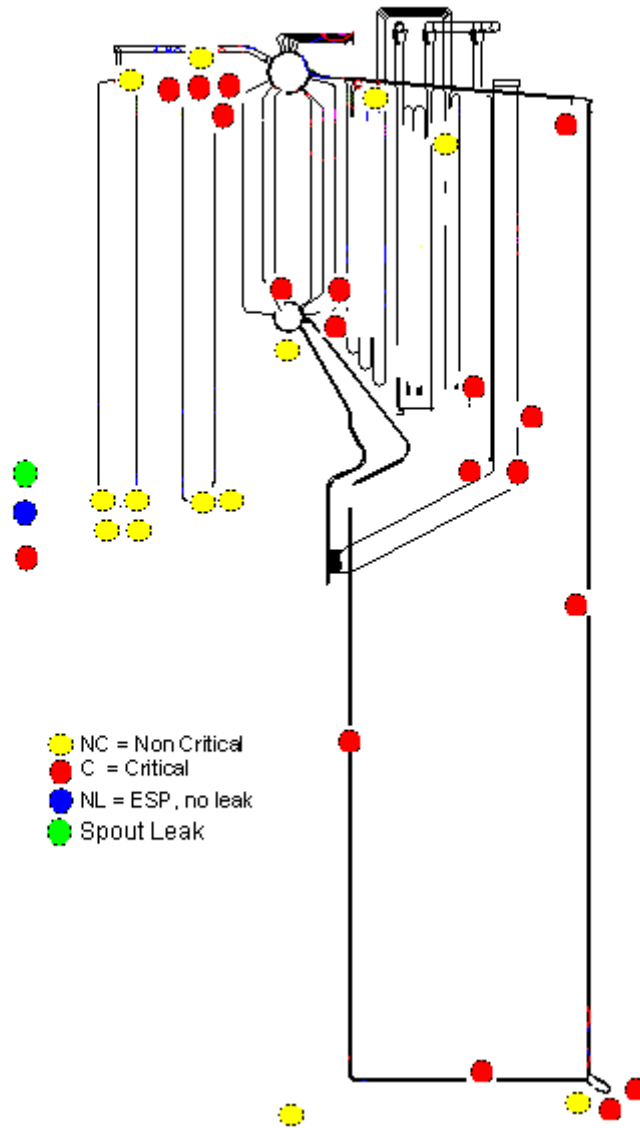
Figure 1

Fall 2011 Leak Locations

The general locations of the leaks for boilers in North America are shown in Figure 1, which displays a typical boiler, not representing any particular style or model. The yellow marks are the non-critical incidents and the red marks indicate the location of the critical incidents. Since the two spout leaks were both classified as critical, they are indicated by red dots at the spout level. One incident reported a Feedwater Air Heater Leak and that is represented by the yellow dot below the furnace.

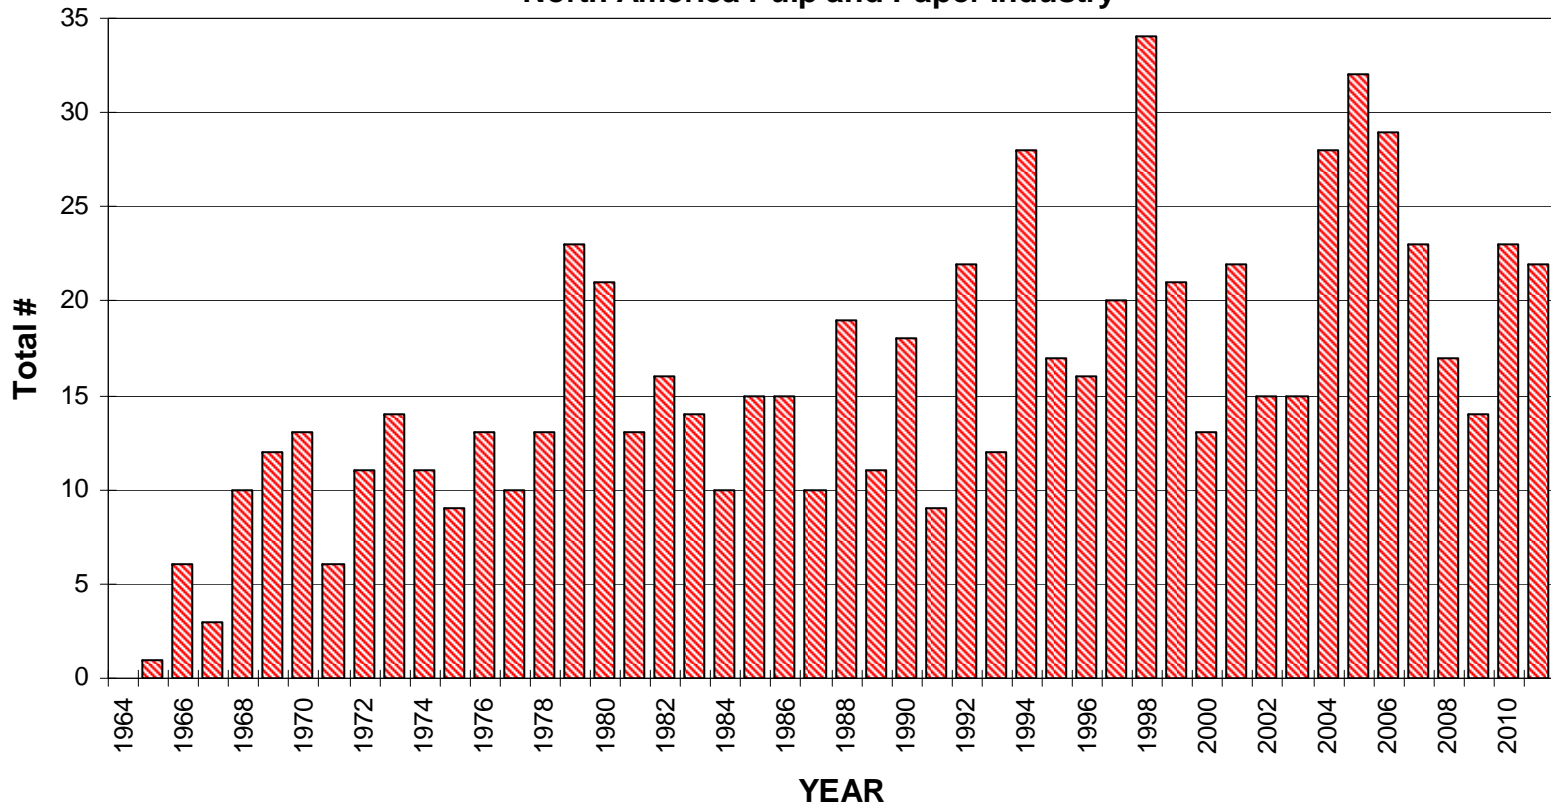
**Figure 2**  
**(Critical Exposure Classification Began in 1965, Changed to Critical Incident in 1999)**

### KRAFT RECOVERY BOILER CRITICAL INCIDENTS North America Pulp and Paper Industry

Figure 2 shows the critical incidents reported each year. One reason for the recent increase is we are including leaks in critical areas that were discovered during a shutdown because they were probably leaking while the boiler was in operation.
