BLACK LIQUOR RECOVERY BOILER

ADVISORY COMMITTEE

MINUTES OF MEETING

March-April 30, 31 & 1, 2015

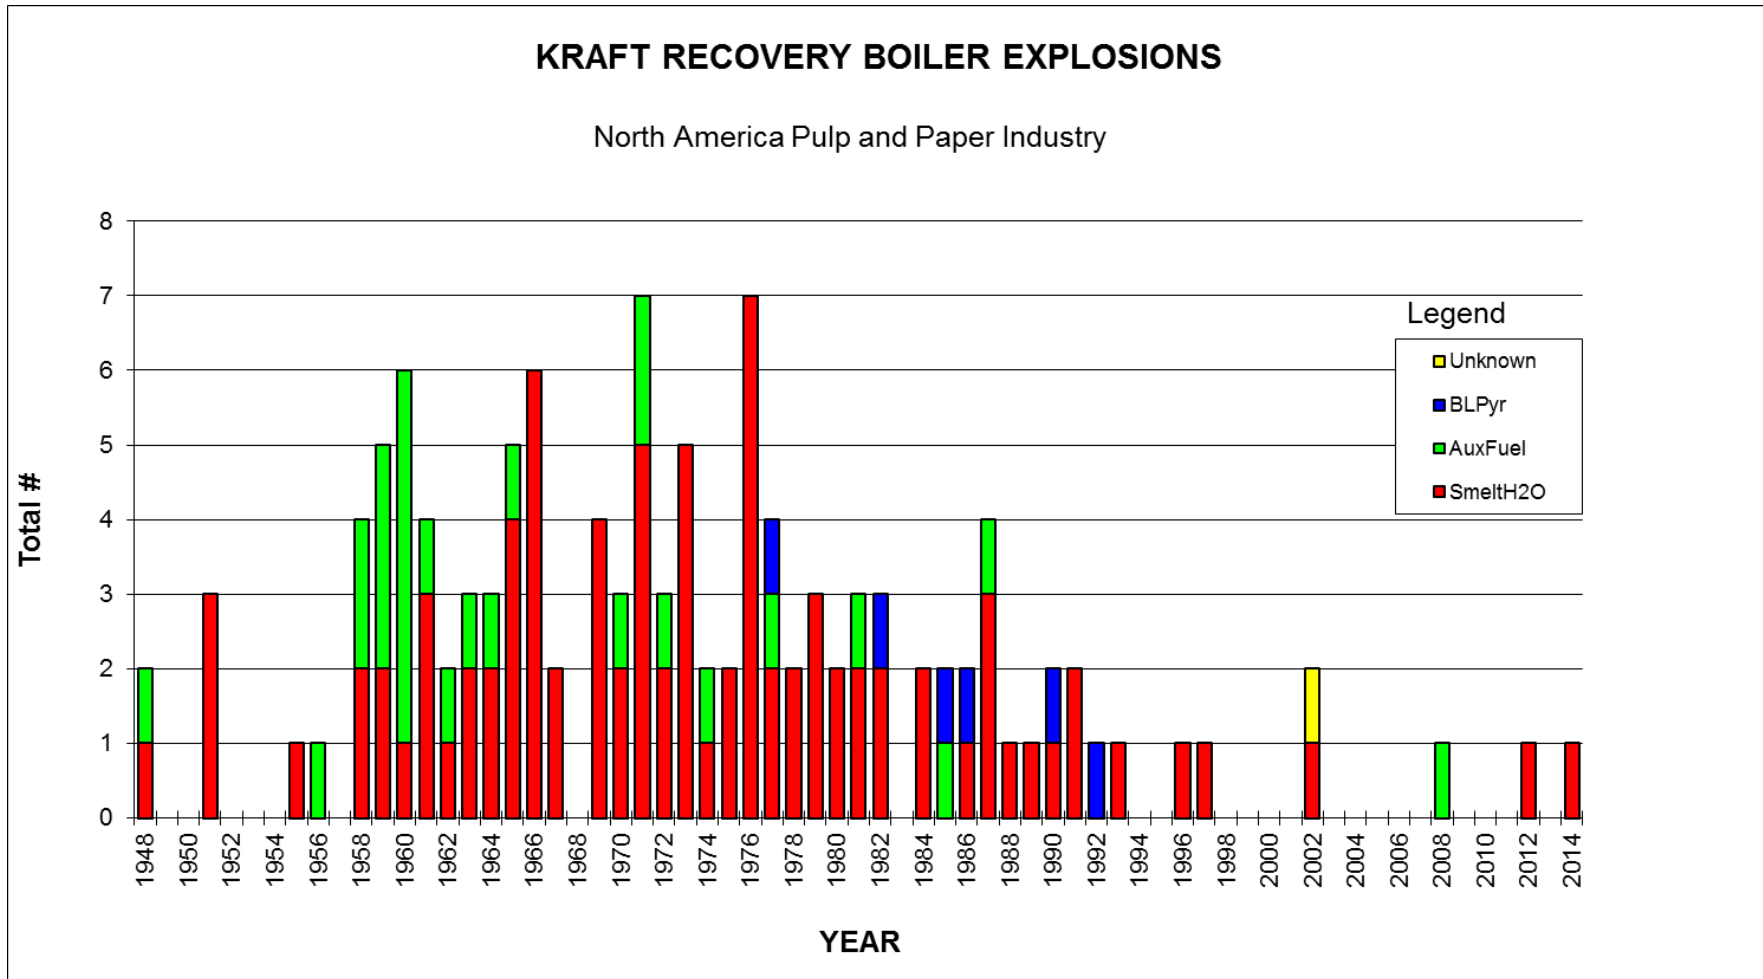
(Critical Exposure Classification Began in 1965, Changed to Critical Incident in 1999)

Figure 2 shows the critical incidents reported each year. The bar for 2015 just represents the leaks reported in the Spring Meeting. Figure 3 shows the history of Recovery Boiler Explosions showing the smelt water explosion reported last year and the one from 2012.
